# Table of Contents

## Inspection Report Exclusively For: Buyer-032811PW

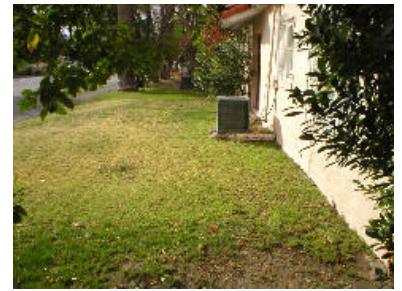
[CR] The yard grading at areas around the house are not adequately sloped away from the perimeter foundation. It is important that surface grade be sloped away from the perimeter foundation to prevent moisture accumulation next to the foundation and into the foundation slab.

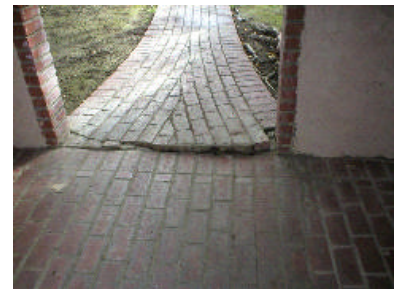
[SC] Uneven sections are noted in the walkway surface. This condition is a trip hazard.

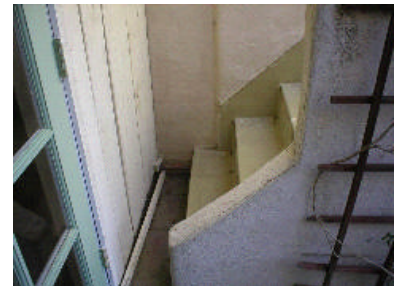
[SC] There is insufficient ceiling head height and insufficient access width/turning area to the stairs to the low slope roof. This configuration is improper.

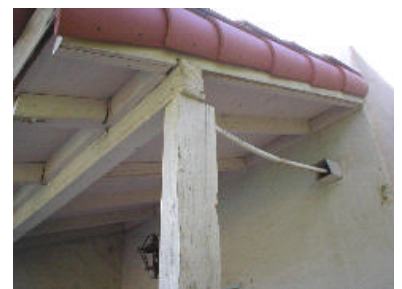
[SC] The old patio cover next to the low slope roof at the left rear is of substandard construction. The roof is inadequately supported at the wall and at the wood post on the block wall. There are no metal bracket/connections keeping the structure together in an earthquake. The roof at this area is leaking, moisture stains are noted.

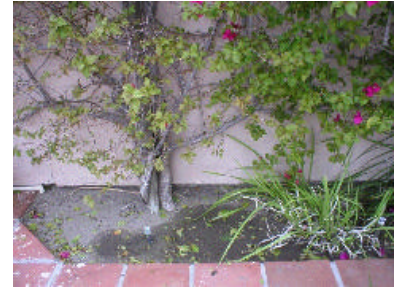
[CR] Building standards require a minimum of 4 inches clearance between the soil and any wood/metal construction. We recommend maintaining this clearance as much as is practical without creating a negative slope towards the structure. The structure does not comply with this requirement.

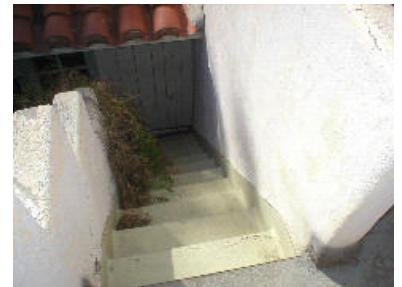
[SC] There are no handrails at the stairs as required.

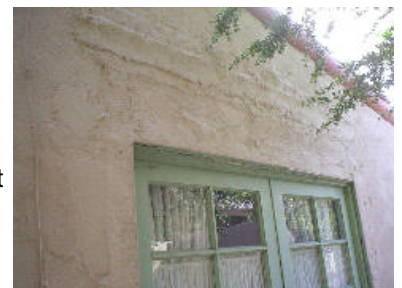
[CR] The stucco siding has moisture damage/deterioration at several locations of the building. See above.

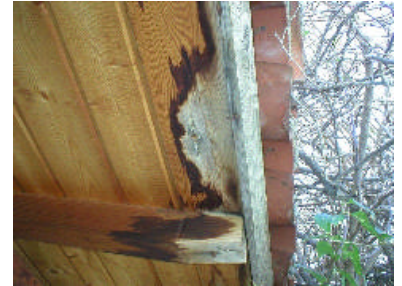
[FE] There are moisture stains and some deteriorated eave and soffit materials noted.

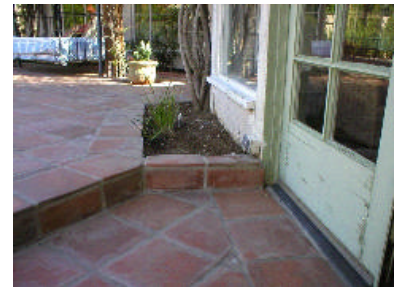
[CR] The raised planter enclosure's adjacent to the foundation at the rear patio is conducive to moisture intrusion and deterioration. The planters are improperly built and does not have the required air gap. Discolored interior tiles are noted due to moisture intrusion.

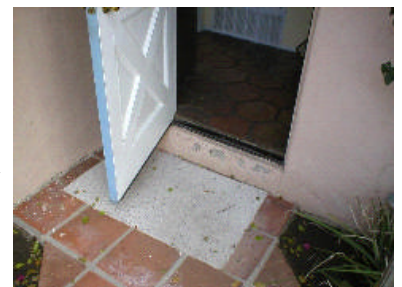
[SC] Most of the doors swing out over step downs greater than 1 1/2 of an inch, these conditions are blind trip hazards. Photo is of the door off the driveway into the house.

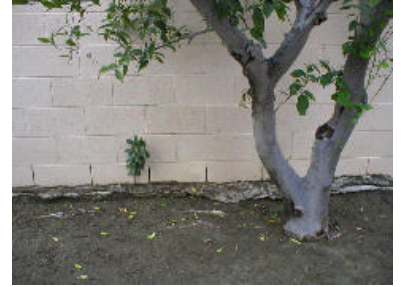
[CR] The left side of the driveway concrete block yard wall has an exposed foundation needing correction.

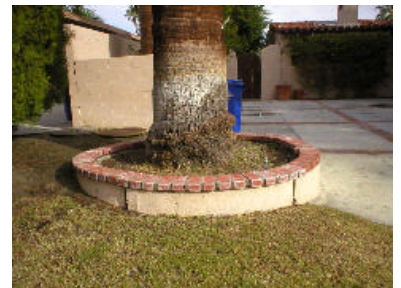
256 RETAINING WALL(S) [CR] The decorative retaining/planter walls are cracked at the driveway tree.

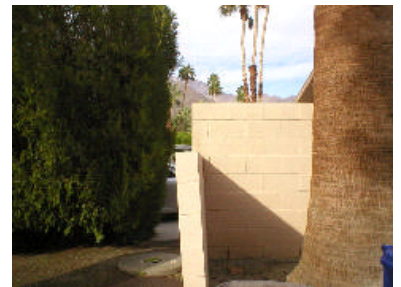
[CR] The concrete block fence is leaning at the left side of the driveway. Photo.

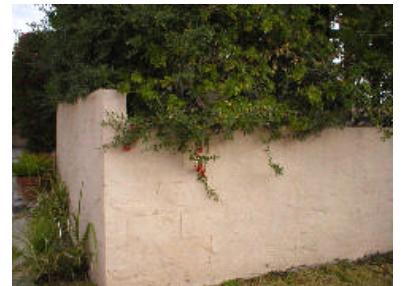
263 COMMENTS [CR] The perimeter yard masonry fencing has cracks in the walls.

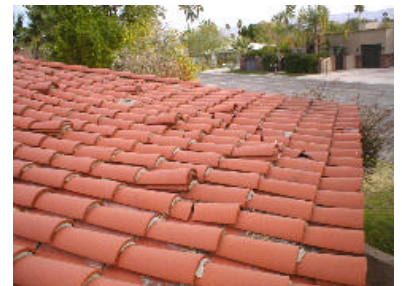
- 310 CLAY TILES** [FE] There are a number of cracked, broken and displaced tiles on the roof. The underlayment felt is exposed to the weather. The underlayment does not extend beyond the eave edges. These conditions are conducive to roof leaks. All locations. Photo is of the front right corner, the damage at this area appears to be from tree limbs.

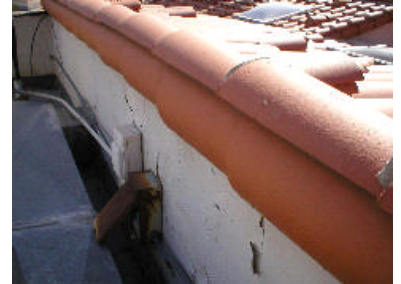
[CR] The material on the parapets is cracked, deteriorated and peeling. This condition is conducive to leakage.

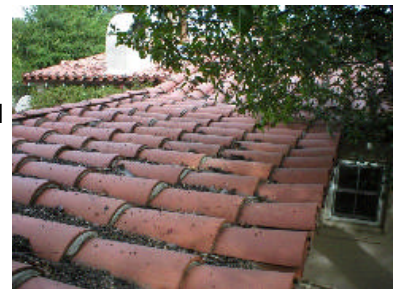
[CR] The tiles are installed over a surface with a slope of less than 3 in 12 and are subject to leakage due to poor drainage. Heavy underlayment is noted under the tiles. Tree debris is noted needs to be removed. Noted at the area over the laundry and the arched entrance.

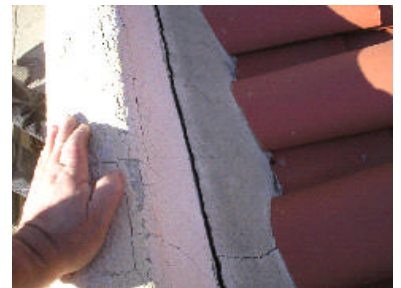
[CR] There are substandard, damaged and missing flashings at the area over the dining room to the clay tile connection. There are no drip edge flashings. Improper flashings at the tile valleys and house wall connections

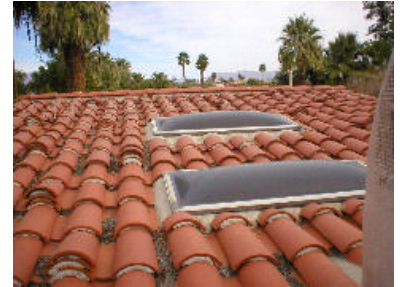
- 325 SKYLIGHT(S) [FE] The skylight lens are cracked/damaged. Master
- [CR] There are no crickets or diverters in the roof behind the skylights. These devices divert roof runoff around the skylights and reduce the potential for leakage. There are no visible flashings at the skylights.

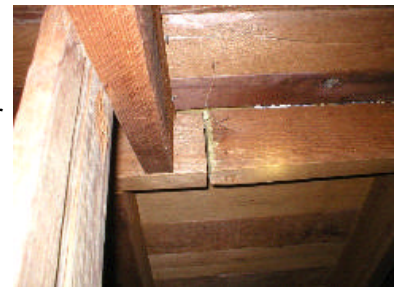
| 407 | <b>ROOF RAFTER(S)</b> | The visible areas of the rafter framing appeared functional, with exceptions noted.<br><br>[CR] Butt joint noted at the ridge beam needs a proper connection. Noted at the off kitchen access. |

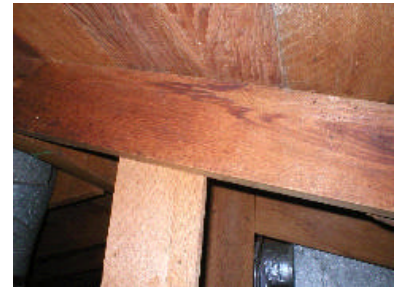
- 414 **ATTIC ACCESS(S)** The attic examination is conducted from the openings only due to limited access.
- 415 **COMMENTS** [FE] Moisture stains noted at the roof framing.

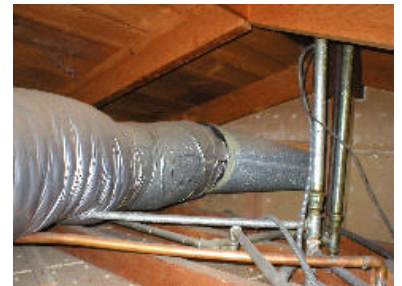
| 507 | <b>WATER PIPING</b> | <p>The visible water supply piping appeared functional, with exceptions noted elsewhere in the report.</p> <p>[CR] Copper plumbing pipes and metal electrical conduit are in contact with each other. This condition can lead to corrosion/electrolysis between these dissimilar metals. Noted in the attic at the right side.</p> <p>[RU] There are un-insulated water supply pipes.</p> |

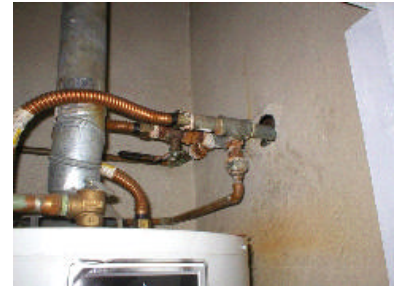
[CR] The water supply connectors are corroded.

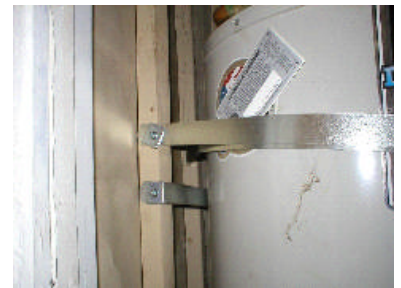
537 **SEISMIC BRACING** [SC] The water heater seismic strapping is installed in a manner that did not meet the State Architect's requirements or the water heater strapping kit manufacturers instructions. The intent is for the water heater to resist movement. The straps are fastened into wood that is less than a stud size. The blocking of the water heater to restrict movement is inadequate.

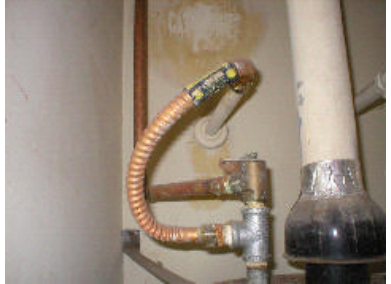
- 536 **TANK(S)** [FE] The metal casing of the water heater tank is corroded/deteriorated.
- 537 **SEISMIC BRACING** [SC] The water heater is not double strapped and stabilized/blocked as required by the State Architect to resist movement.

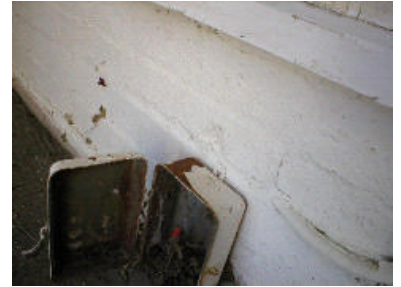
- 610 GROUND TYPE(S) [FE] The grounding connections are not visible.
- 611 GROUNDING [FE] The grounding connections are not visible/located. Recommend to locate. If none found we recommend to upgrade the grounding system.
- 612 COMMENTS [SC] Old timer control box in a yard planter that is missing its timer, has exposed wires and holes in the box, corroded conduit is noted.

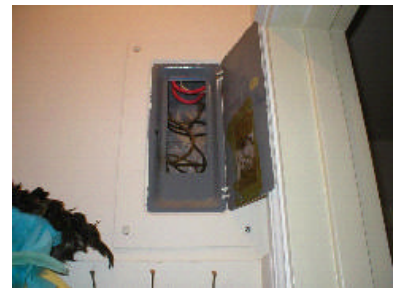
- 618 ELECTRIC PANEL [SC] The panel is now redundant and in use as a junction box. The cover needs to be screwed shut. This condition is a safety hazard.

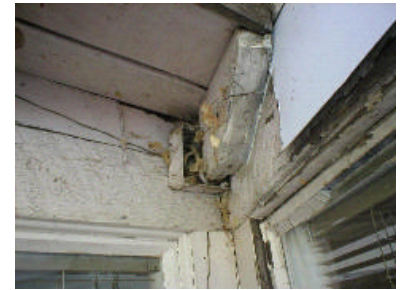
[SC] Electrical box missing cover at the eave at the area over the dining room. The box is not accessible as required.

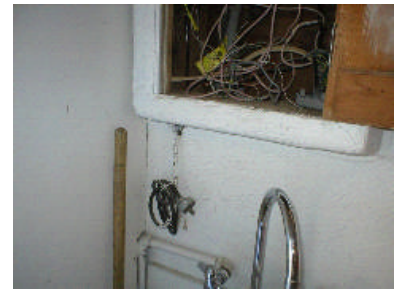
[SC] Exposed wiring in the wall cabinet and improper wiring passing through the wall in the laundry.

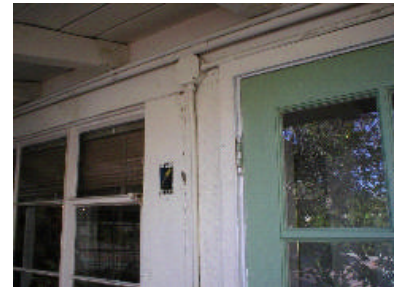
[SC] Exterior J box with exposed wiring. Rear french doors behind the kitchen.

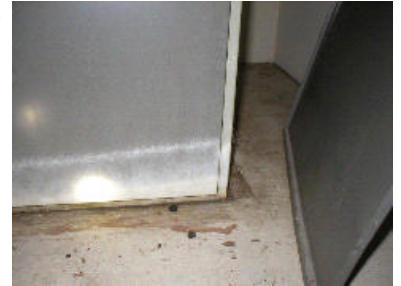
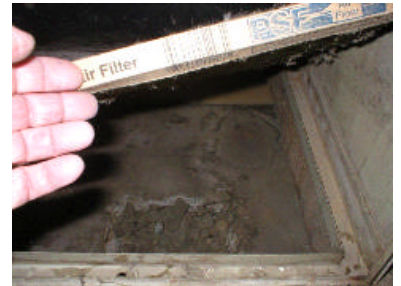
- 715 THERMOSTAT(S)** The thermostat was operated and the system responded.
- [CR] Thermostat is missing its plastic "glass" at the dining area.
- 716 COMMENTS** [CR] The return air plenum is dirty. We recommend cleaning this area of all dirt and/or debris.

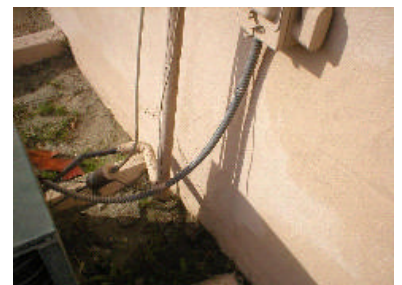
[SC] There is not adequate clearance to the electrical disconnect at the roof, the disconnect is corroded.

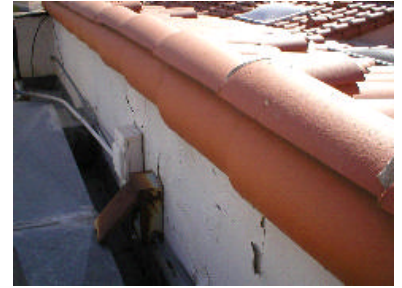
[CR] The electrical disconnect is rusted/deteriorated and access is inadequate. The electrical conduit is deteriorated and there are holes in the box. Left rear at the roof.

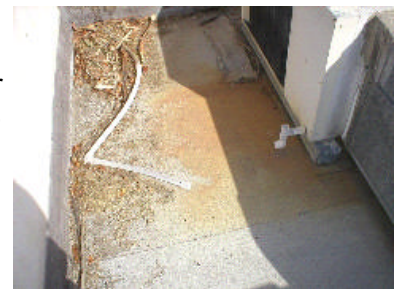
730 CONDENSATE DRAIN(S) [CR] The condensate drain lines are installed improperly. The trap and vents are missing. The lines have a negative slope. The lines on the roof at the rear of the master bedroom are broken. The line penetrates a parapet wall drain.

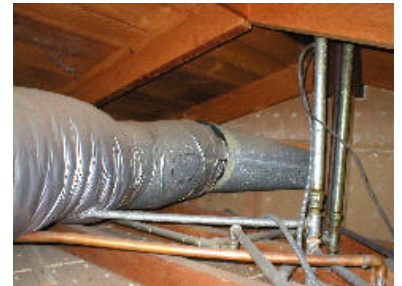
[CR] Metal duct sections are missing insulation.

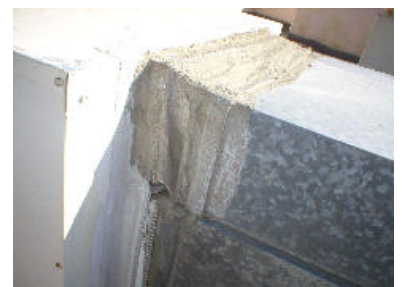
735 COMMENTS [CR] There are conditioned air ducts at the roof over the master that have holes noted at the joint connection.

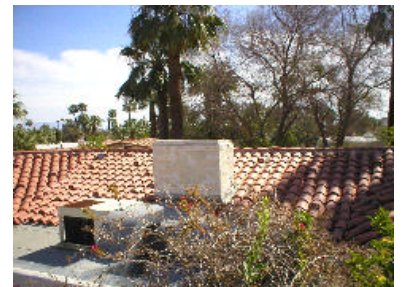
| <b>806 SPARK ARRESTOR(S)</b> | <p>There is a spark arrester installed on the master chimney.</p> <p>[SC] There are no spark arresters installed on the masonry chimney. We recommend installing rain cap type spark arrester to help minimize moisture entry into the flue and prevent the escape of hot embers.</p> |

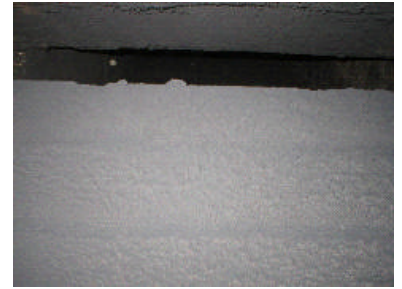
[SC] The visible areas of the flues are dirty with soot/creosote build up. We recommend the flues and related components be cleaned by an appropriate professional in the appropriate trade. Living/dining rooms.

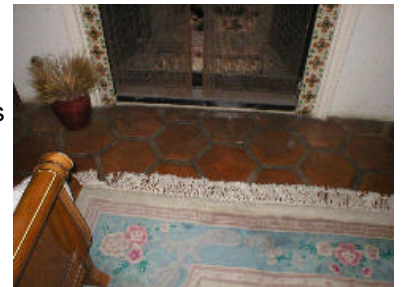
[SC] The hearth extensions are not distinguishable from the surrounding flooring. This condition increases the potential for combustible materials be placed too close to the fireplace. This condition is a fire safety hazard. We recommend correcting the conditions noted or use caution in placement of items near fireplaces. Master and dining room.

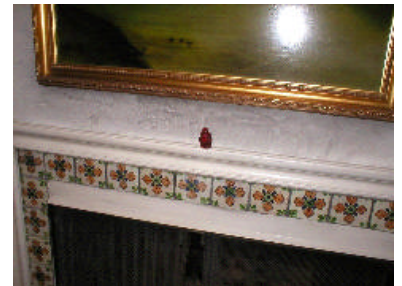
[SC] The wood mantle and wood sides are too close too the fireplace opening. This condition is a fire hazard. Master.

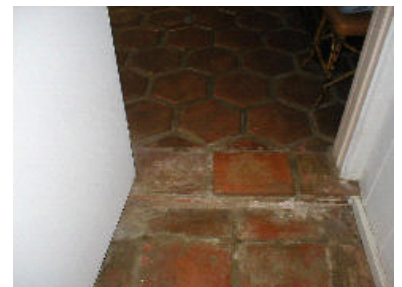
- 923 STAIRWELL(S)** **[SC]** There are improper/inconsistent rise/height on the various steps in the home. The step material is the same as the tile and not delineated. This causes the human eye to not "see" the steps. This condition is a trip hazard.

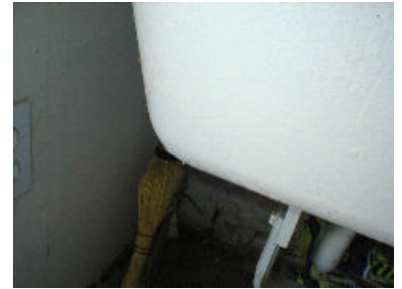
- 963 WASHER SERVICE The laundry faucets have no visible leaks, a machine is connected. We do not operate the faucets.
- 964 DRYER SERVICE The dryer hookup is provided for a gas unit.
- 965 DRYER VENT(S) Dryer venting is provided and terminated at the exterior.
- 966 COMMENTS [FE] There is evidence of what appeared to be an unknown black/brown substance under the laundry sink. Damage noted to the walls.
- [NOTE] The laundry appears to be built on the patio tile not the house slab.

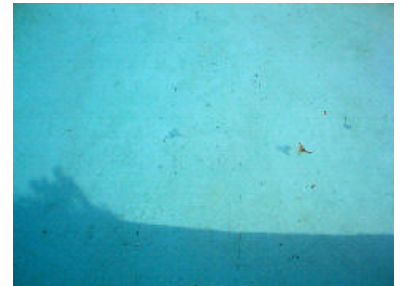
1007 VESSEL [FE] The following vessel conditions were noted: areas of chipped plaster and cracks were noted.

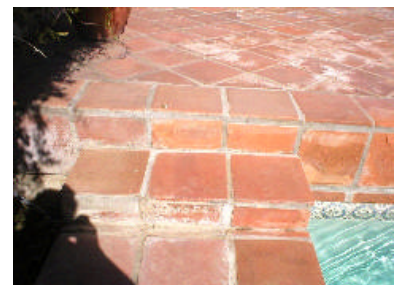
[SC] Pool step rise/heights are inconsistent. This is a trip hazard.

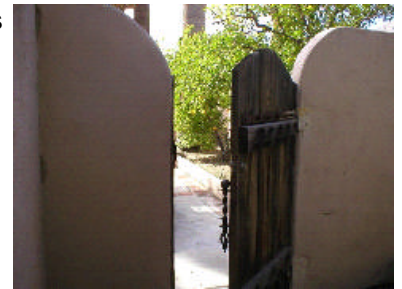
[SC] The gate opened toward the pool. The gate closer was missing. The gate latch was in the wrong location and the wrong type. We recommend correcting the conditions noted for child safety. These requirements are to protect kids from wandering on the property from the street and family/friends with kids.

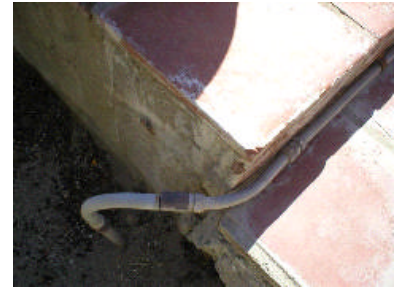
[SC] The conduit connection was loose from the pump/motor, the timer control and at the rear of the pool deck.

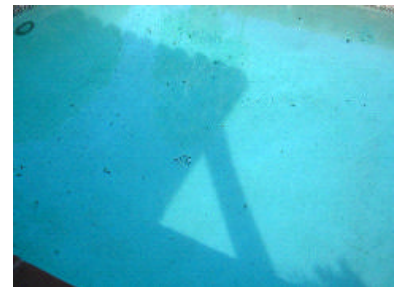
[SC] The drain cover is the old type/design that present a safety hazard due to suction entrapment. We recommend the cover be replaced with the safety/anti vortex type.

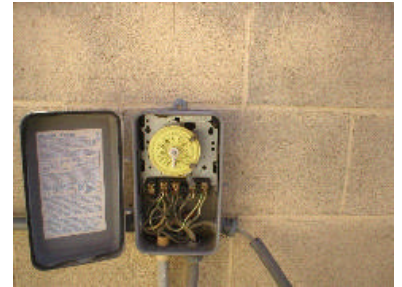
[SC] The wire protector was missing from the timer. Exposed live wires are present. Damaged separated conduits are noted in several locations at the system.

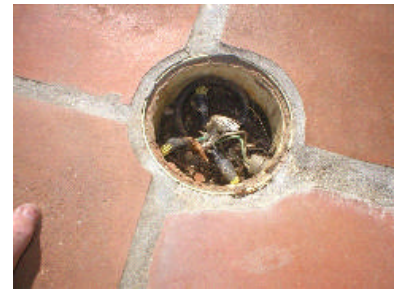
[SC] The pool light electrical deck box was missing the weather tight cover. This allows water access to live wires.

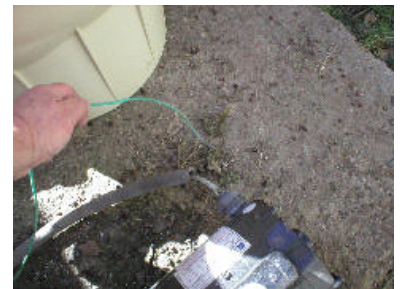
[SC] The pump has no connection to the bonding system [green wire], the bond wire is too small. Separated conduits are noted.

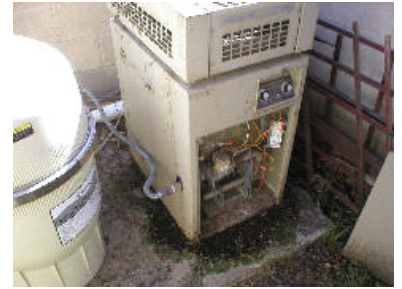
[FE] The heater failed to function. The gas supply to the pool appears to be too small, this needs to be evaluated for condition and size. The house gas meter appears to be too small for the house and pool gas demand.

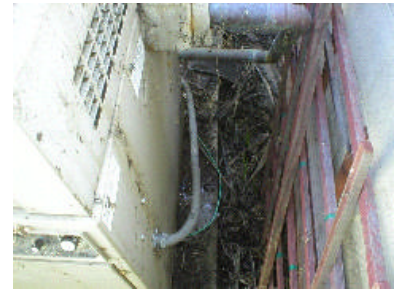
[CR] The header connection on the heater is leaking.
