# Table of Contents

## Inspection Report Exclusively For: Buyer-032811PW

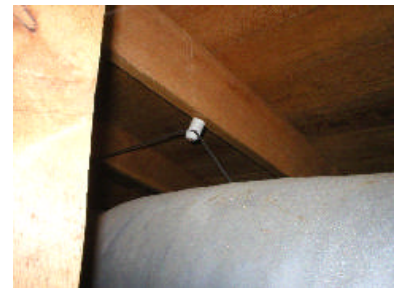
601 SERVICE TYPE	Underground.
602 MAIN PANEL	Located at the left side of the master bedroom wall.
603 SERVICE RATING	120/240 volt system, rated at 200 Amperes.
604 SERVICE WIRING	Materials: copper.
605 CIRCUIT WIRING	Materials: copper, Wire system type(s): non-metallic sheathed cable and conduit.  [SC] Some knob and tubing noted. Knob and tubing is the original wiring method. It uses wiring that is exposed and unprotected and is prone to physical damage. It is not grounded.  [FE] [SC] The old knob and tubing is visible in places in the attics. Recommend this be properly terminated/removed.
606 DISCONNECT TYPE	Circuit breakers.

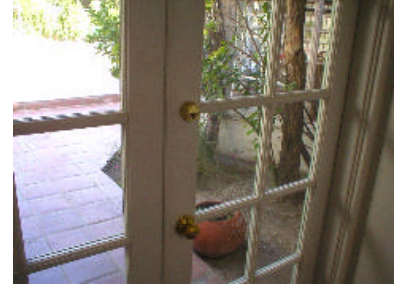
**[CR]** Windows have cracked glass at the dining area and at the right side rear hallway.
- 918 SECURITY BARS** **[SC]** The bedroom security bars are the non release type, this is a hazard. This is mitigated by the french doors for safe egress in a fire as long as the doors are not keyed both sides.
